**DOT/FAA/TC-17/18**

# **Effects of Repair Procedures on Bonded Repairs of Airframe Structures**

November 2017

Final Report

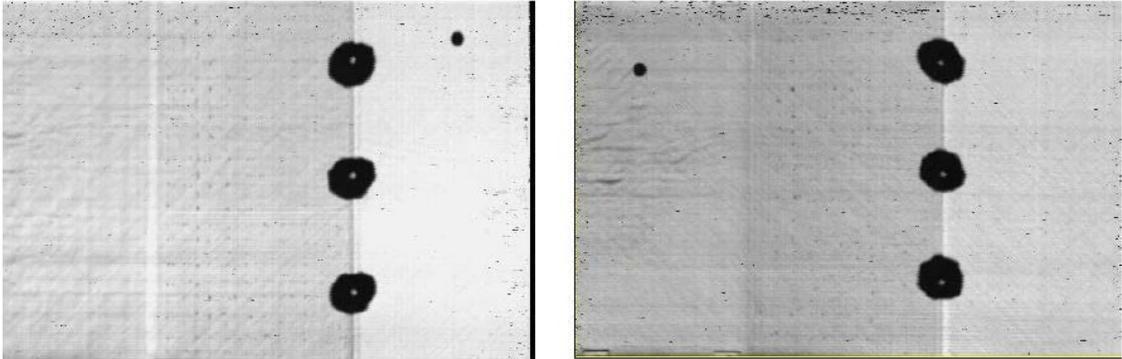
**Figure 38. C-Scans of 48-E2-20-TN-RTA/48-E2-20-TN-RTF panels**

Figures 37–40 show typical C-Scans of the repaired panels prior to machining them into individual specimens. It should be noted that the variability in the planar damage area resulted from varying impact sites.

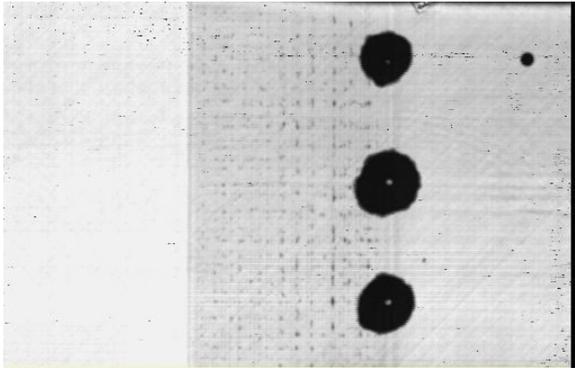
**Figure 39. C-Scan of 48-E2-20-TF-RTF panel**

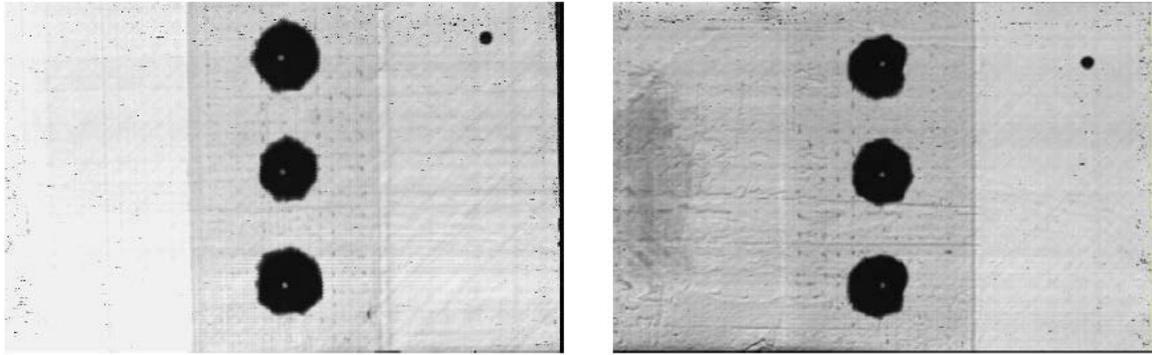
**Figure 40. C-Scans of 48-E2-20-CN-RTA/48-E2-20-CN-RTF panels**

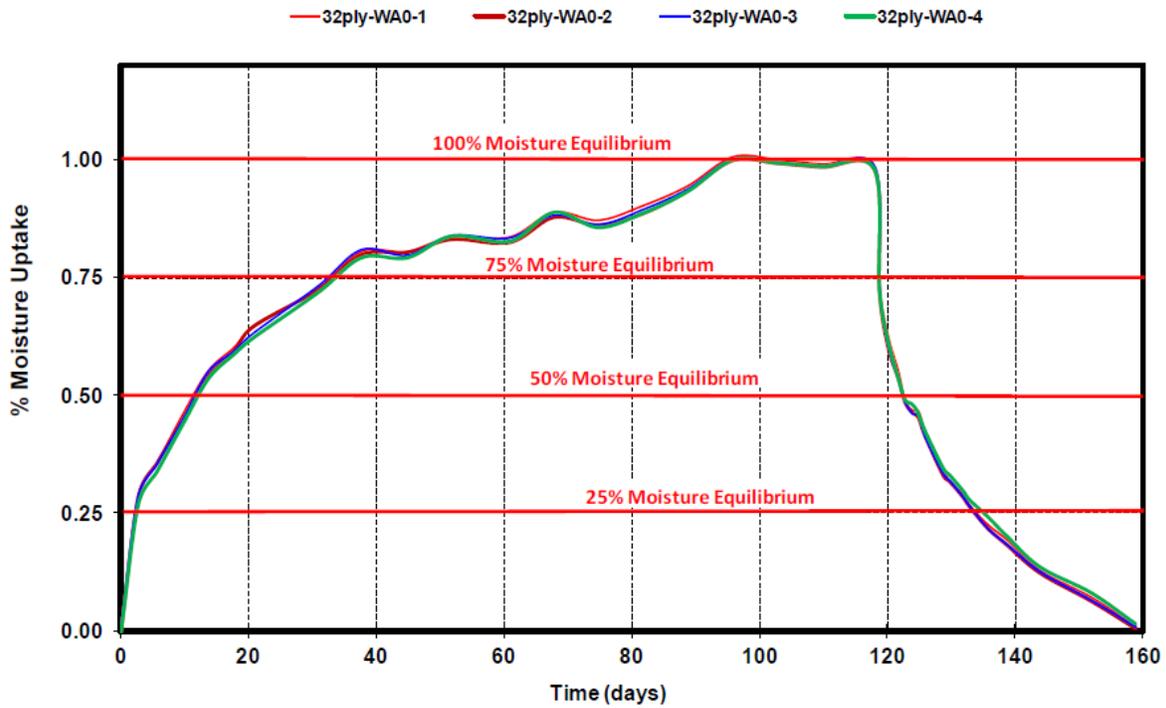
For the samples exposed to water (water contaminated samples)—referred to as WA0, WA25, WA50, and WA75—moisture equilibrium was achieved by exposing these samples to  $85\% \pm 5\%$  relative humidity and  $180^{\circ}\text{F} \pm 5^{\circ}\text{F}$  until equilibrium moisture gain was achieved ( $\sim 1\%$  total percent moisture weight gain referred to as 100% moisture equilibrium). These samples were then dried to achieve  $\sim 0.75\%$ ,  $0.5\%$ ,  $0.25\%$  moisture weight percent referred to as 75%, 50%, and 25% moisture equilibrium, shown in figure 41. Once the desired moisture levels were achieved, the samples were removed from the chamber and repaired as per the procedure specified in section 2.5.

**Figure 41. Moisture absorption/desorption cycle for 32-ply laminates (parent material)**

Figure 41 in section 2.8 shows a sample moisture absorption/desorption curve for traveler specimens used to monitor moisture content for the water-contaminated samples. The scarfed panels were conditioned until moisture equilibrium was achieved, resulting in approximately 1% total moisture content, as shown in the figure. The scarfed panels were then dried to achieve moisture levels equivalent to 75%, 50%, and 25% of the level achieved at equilibrium, denoted as WA75, WA50, and WA25. The WA0 samples were fully dried after reaching moisture equilibrium. It took less than 24 hours to dry the 32-ply scarfed panels to a 75% moisture equilibrium level (0.75% effective moisture content by weight), approximately 5 days to dry the

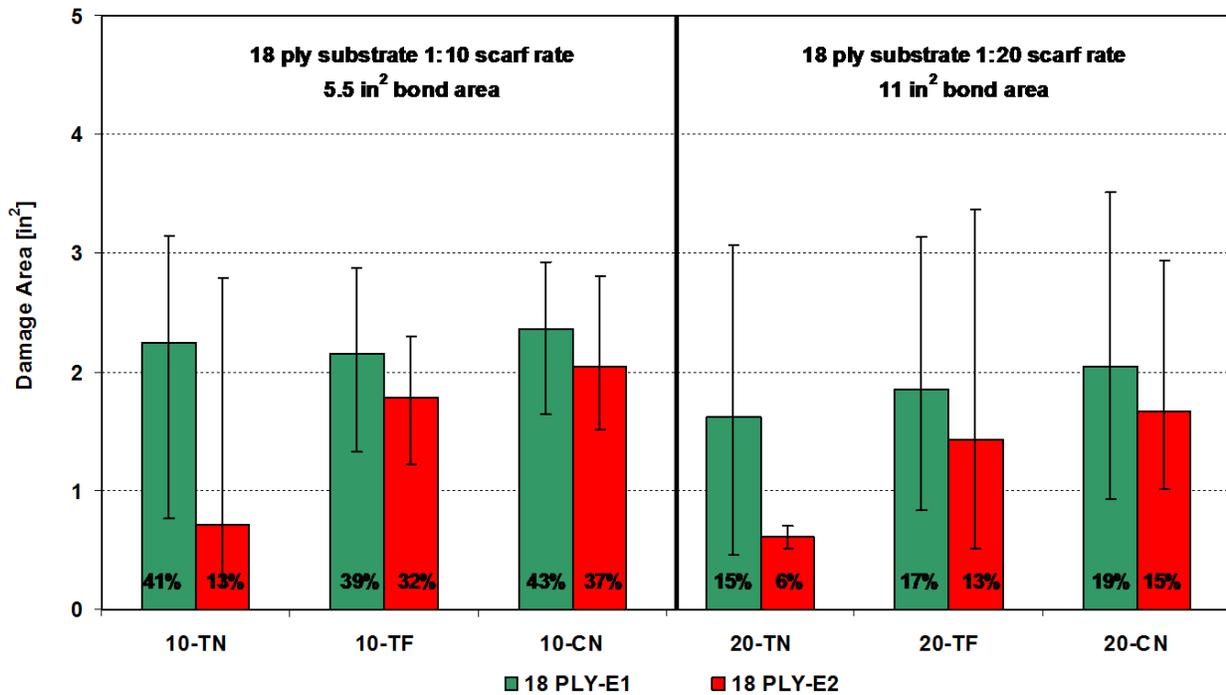
Figure 44 shows a summary of C-Scan damage areas for all 18-ply scarf repairs after impacts. Figures 45–56 are representative C-Scan images obtained for all specimens subsequently tested at room temperature. If one disregards the high scatter for all 18-ply-E1 substrate specimens, the same energy level inflicted at different sites in the repair yielded comparable average planar damage areas for all 1:10 specimens (figure 44). A close examination of the C-scans shows a large scatter in the damage areas obtained for identical samples impacted with the same energy level. The corresponding damage areas represent 41%, 39%, and 43% of the joint overlap area for the 18-ply-E1-10-TN, 18-ply-E1-10-TF, and 18-ply-E1-10-CN configurations, respectively.

For all 18-ply-E1-20 substrate specimens, increasing damage size was observed for the TN, TF, and CN configurations, with the center impacts yielding the most severe damage. For the 1:20 configurations, the average damage areas correspond to 15%, 17%, and 19% of the joint area for the 18-ply-E1-20-TN, 18-ply-E1-20-TF, and 18-ply-E1-20-CN configurations, respectively. Comparing the 1:10 and 1:20 configurations with the same substrate E1, figure 44 shows that the larger repairs (i.e., 1:20 configurations) was less damaged under the same energy level applied.

For all 18-ply-E2 substrate specimens considered, regardless of scarf ratio, the TN impacts yielded the smallest damage areas, followed by the TF impacts and the CN impacts. The same energy level inflicted at different sites in the repair yielded different damage sizes with the

impacts inflicted at the CN being the most severe. Comparing the 1:10 configurations to the 1:20 configurations for the same substrate (18-ply-E2), the data show that the same energy level inflicted on the same location in two joints of different sizes yielded a smaller damage area for the larger repair. The damage areas for the 1:10 configurations correspond to 13%, 32%, and 37% of the joint area for 18-ply-E2-10-TN, 18-ply-E2-10-TF, and 18-ply-E2-10-CN, respectively. For the 1:20 configurations, the damage areas correspond to 6%, 13%, and 15% of the joint area for 18-ply-E2-20-TN, 18-ply-E2-20-TF, and 18-ply-E2-20-CN, respectively. Based on the impact data generated for the 18-ply repaired laminates, it can be concluded that for the substrate and repair systems under investigation with the corresponding configurations, the larger repairs (1:20) appeared to be more damage tolerant than the smaller repairs (1:10).

Figure 44. Impact data summary for all 18-ply scarf repair specimens

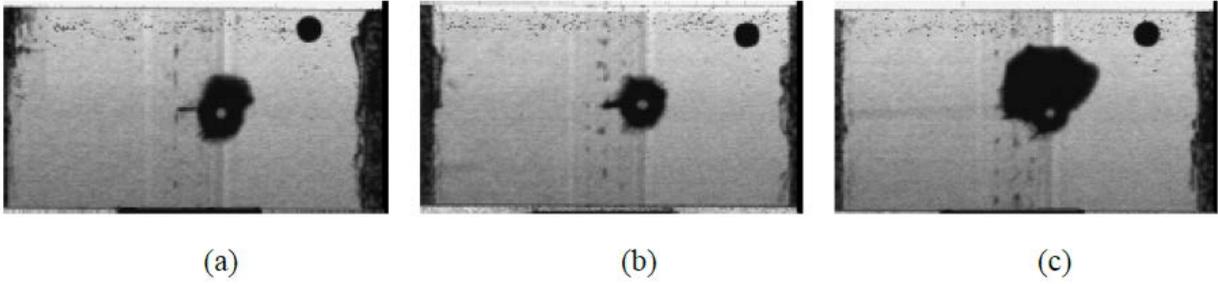
**Figure 45. C-Scans of 18-ply-E1-10-TN-RTA of damage area and depth, respectively: (a) 1.22 in<sup>2</sup>, 0.006 in; (b) 0.94 in<sup>2</sup>, 0.007 in; (c) 2.61 in<sup>2</sup>, 0.006 in**

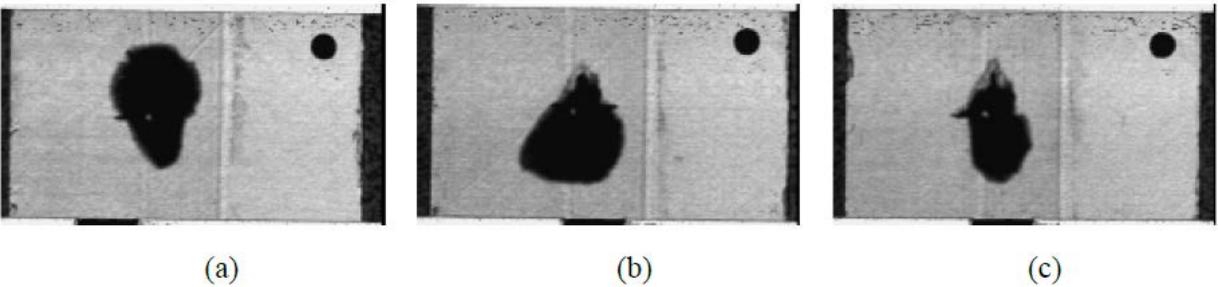
**Figure 46. C-Scans of 18-E1-10-TF-RTA-(1, 2, 3) of damage area and depth, respectively: (a) 2.51 in<sup>2</sup>, 0.0085 in; (b) 2.12 in<sup>2</sup>, 0.01 in; (c) 1.32 in<sup>2</sup>, 0.0105 in**

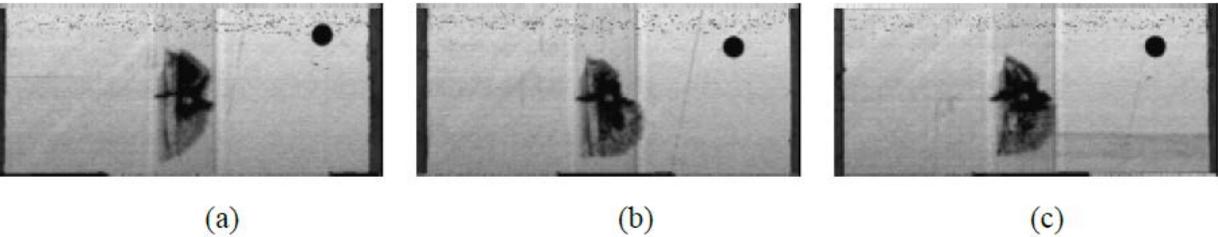
**Figure 47. C-Scans of 18-E1-10-CN-RTA-(1, 2, 3) of damage area and depth, respectively: (a) 1.07 in<sup>2</sup>, 0.0061 in; (b) 1.17 in<sup>2</sup>, 0.006 in; (c) 1.23 in<sup>2</sup>, 0.0065 in**

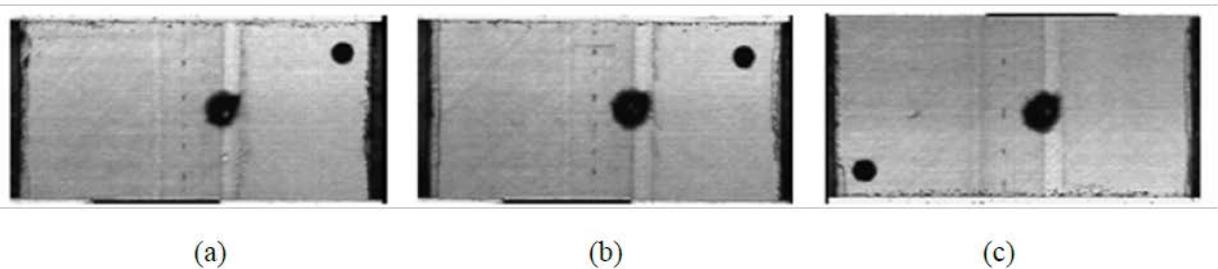
**Figure 48. C-Scans of 18-E2-10-TN-RTA-(1, 2, 3); damage area and depth, respectively: (a) 0.51 in<sup>2</sup>, 0.007 in; (b) 0.66 in<sup>2</sup>, 0.0065 in; (c) 0.62 in<sup>2</sup>, 0.0085 in**

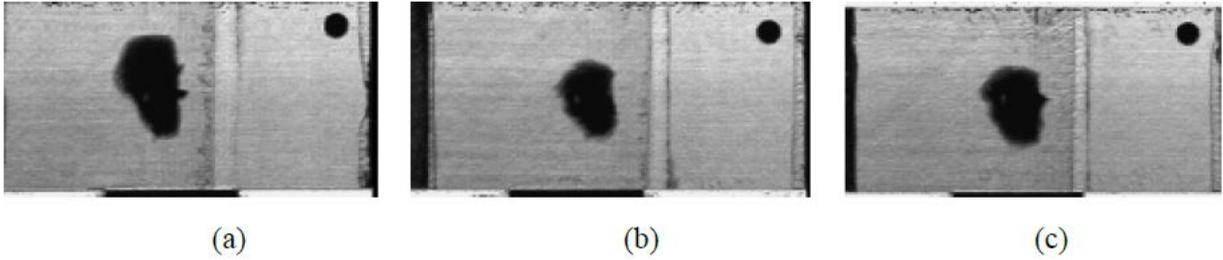
**Figure 49. C-Scans of 18-E2-10-TF-RTA-(1, 2, 3) of damage area and depth, respectively:  
 (a) 2.30 in<sup>2</sup>, 0.0075 in; (b) 1.49 in<sup>2</sup>, 0.0075 in; (c) 1.84 in<sup>2</sup>, 0.008 in**

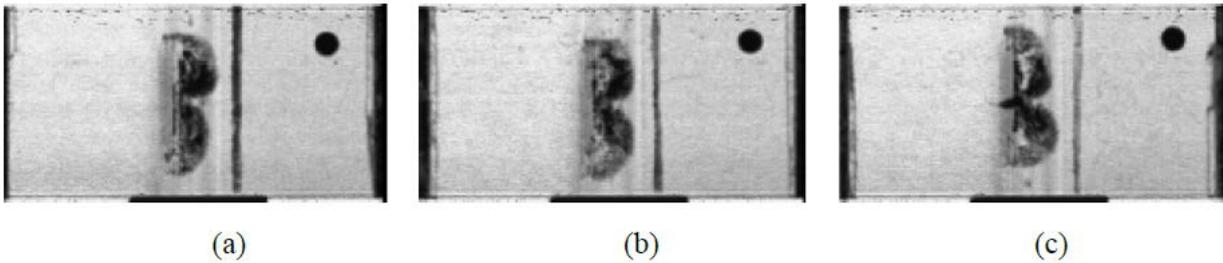
**Figure 50. C-Scans of 18-E2-10-CN-RTA-(1, 2, 3) of damage area and depth, respectively:  
 (a) 1.54 in<sup>2</sup>, 0.0095 in; (b) 1.57 in<sup>2</sup>, 0.004 in; (c) 1.60 in<sup>2</sup>, 0.0055 in**

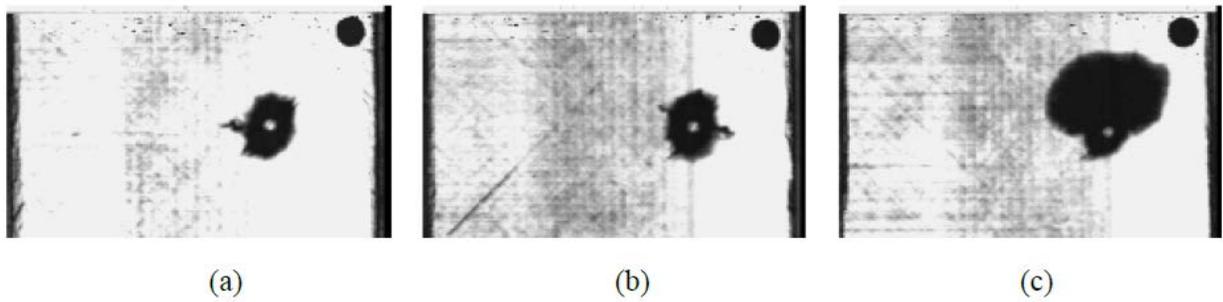
**Figure 51. C-Scans of 18-E1-20-TN-RTA-(1, 2, 3) of damage area and depth, respectively:  
 (a) 0.73 in<sup>2</sup>, 0.0065 in; (b) 0.82 in<sup>2</sup>, 0.0065 in; (c) 2.56 in<sup>2</sup>, 0.0075 in**

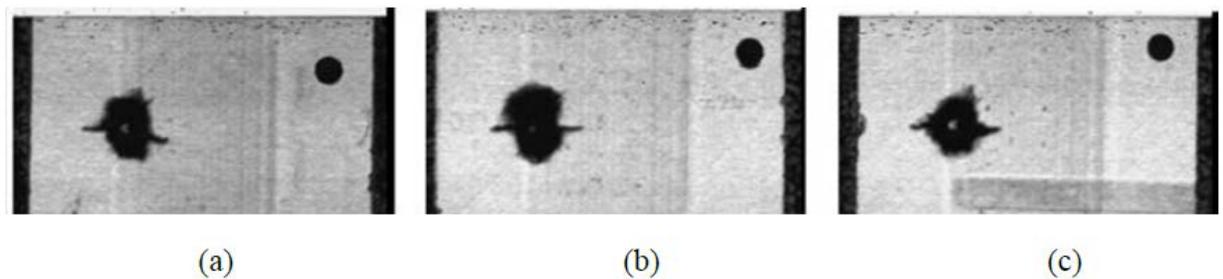
**Figure 52. C-Scans of 18-E1-20-TF-RTA-(1, 2, 3) of damage area and depth, respectively:  
 (a) 0.83 in<sup>2</sup>, 0.0095 in; (b) 1.16 in<sup>2</sup>, 0.0095 in; (c) 0.89 in<sup>2</sup>, 0.0085 in**

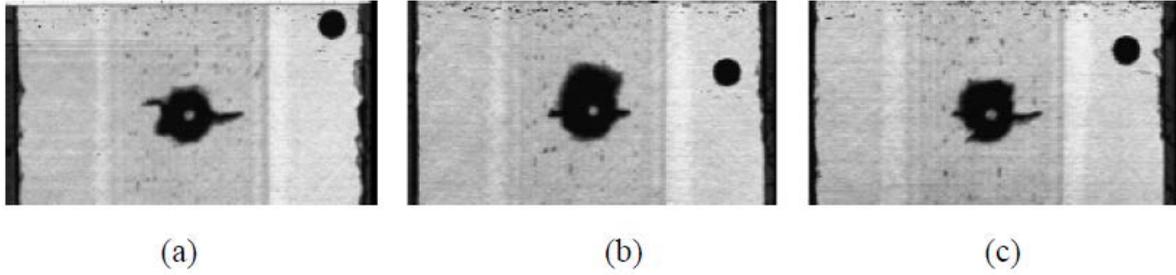
**Figure 53. C-Scans of 18-E1-20-CN-RTA-(1, 2, 3) of damage area and depth, respectively:  
 (a) 0.92 in<sup>2</sup>, 0.0065 in; (b) 1.39 in<sup>2</sup>, 0.0065 in; (c) 1.02 in<sup>2</sup>, 0.0075 in**

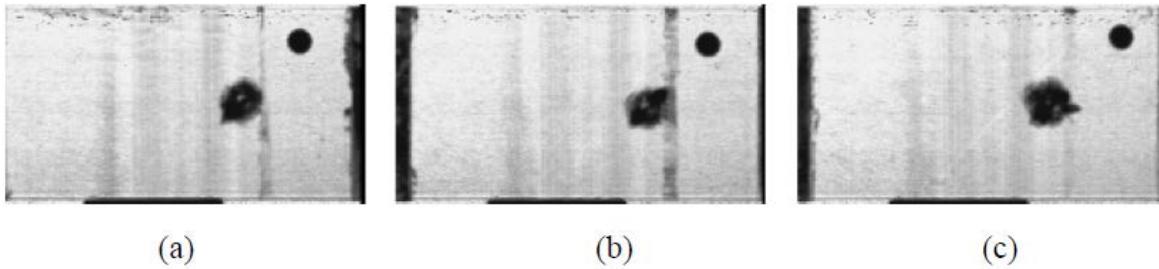
**Figure 54. C-Scans of 18-E2-20-TN-RTF-(1, 2, 3) of damage area and depth, respectively:  
 (a) 0.51 in<sup>2</sup>, 0.0095 in; (b) 0.54 in<sup>2</sup>, 0.01 in; (c) 0.67 in<sup>2</sup>, 0.0085 in**

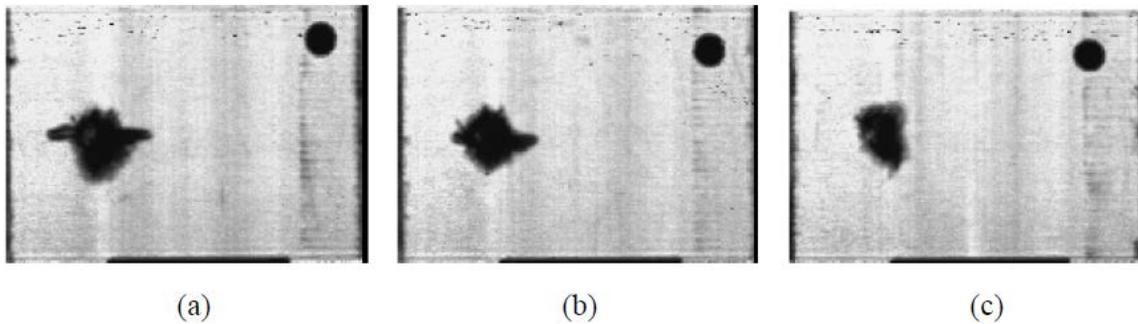
**Figure 55. C-Scans of 18-E2-20-TF-RTF-(1, 2, 3) of damage area and depth, respectively:  
 (a) 0.93 in<sup>2</sup>, 0.012 in; (b) 0.74 in<sup>2</sup>, 0.0115 in; (c) 0.52 in<sup>2</sup>, 0.0095 in**

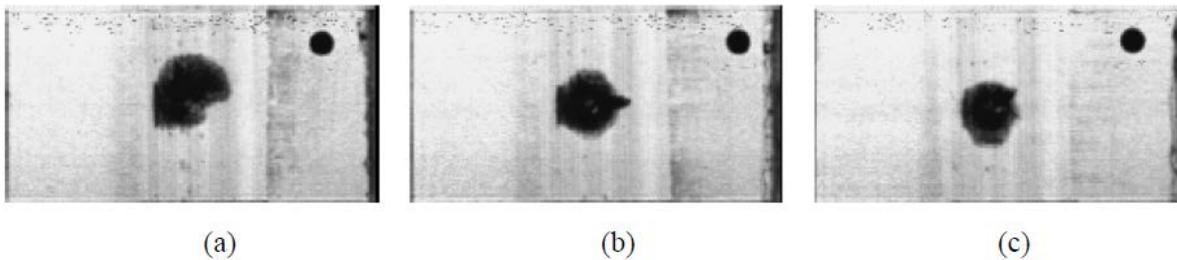
**Figure 56. C-Scans of 18-E2-20-CN-RTF-(1, 2, 3) of damage area and depth, respectively:  
 (a) 1.72 in<sup>2</sup>, 0.006 in; (b) 1.29 in<sup>2</sup>, 0.007 in; (c) 1.11 in<sup>2</sup>, 0.006 in**

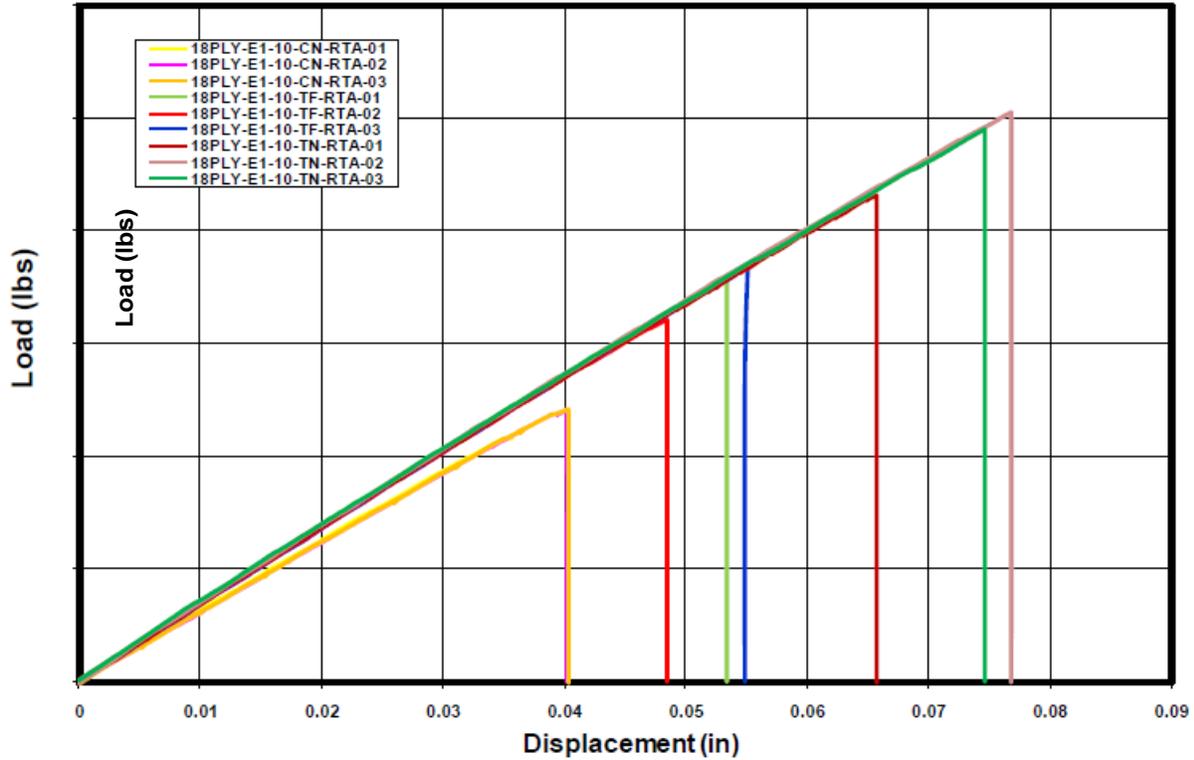
**Figure 57. Representative load vs. displacement curves of damaged 18-ply laminate scarf repairs tested at room temperature (1:10 scarf rate)**

Figures 57 and 58 show representative load displacement curves of damaged 18-ply scarf repairs tested at room temperature. Figure 59 shows the failure loads obtained for all static samples tested at room temperature. These samples were impacted at three different sites in the scarf joints (the TN, the TF, and the CN) using the same energy level, with the intent to induce a barely visible impact damage with a corresponding dent depth of 0.01". The results clearly show that the residual strength of a damaged scarf joint depends on the damage location in the joint.

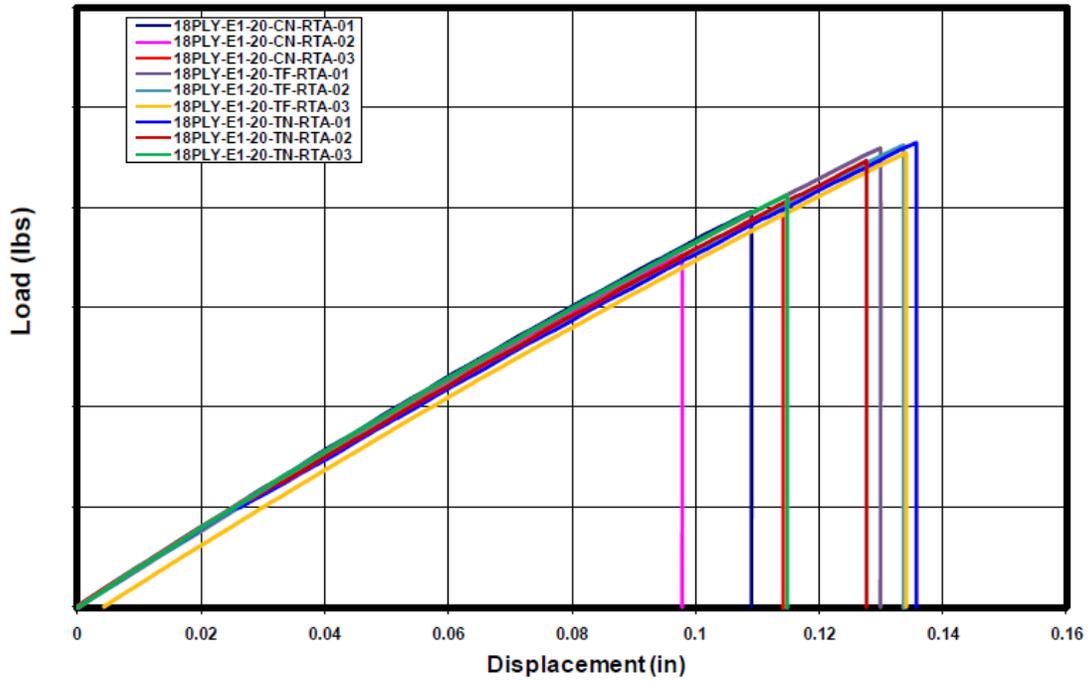
Figure 58. Representative load vs. displacement curves of damaged 18-ply laminate scarf repairs tested at room temperature (1:20 scarf rate)

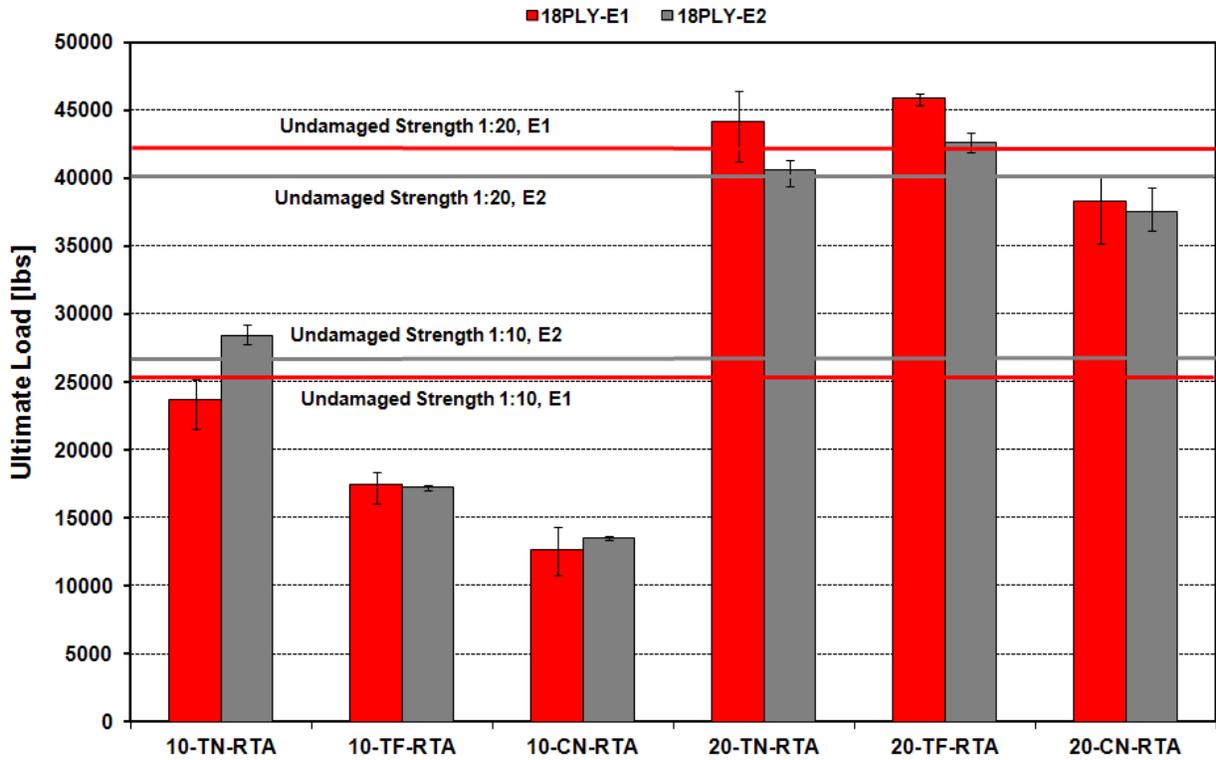
Figure 59. Residual strength after damage (static strength) of 18-ply laminate scarf repair configurations tested at room temperature

The ultimate loads of the 18-ply damaged scarf repairs are compared to those of undamaged repairs. For the 1:10 scarf rate configurations, the TN specimens yielded the highest residual strength, followed by the TF specimens, and the CN specimens yielded the lowest residual strength. For the 1:20 scarf rate configurations, the TF specimens had the highest residual strength, followed by the TN specimens, and the CN specimens yielded the lowest residual strength. The strength degradation observed for the 1:10 scarf repairs was more severe than that observed for the 1:20 scarf repair samples. For the same impact energy level inflicted on the 1:10 and 1:20 scarf repairs, the percentage of residual structurally sound bond area in the joint was higher for the larger scarf repairs (1:20).

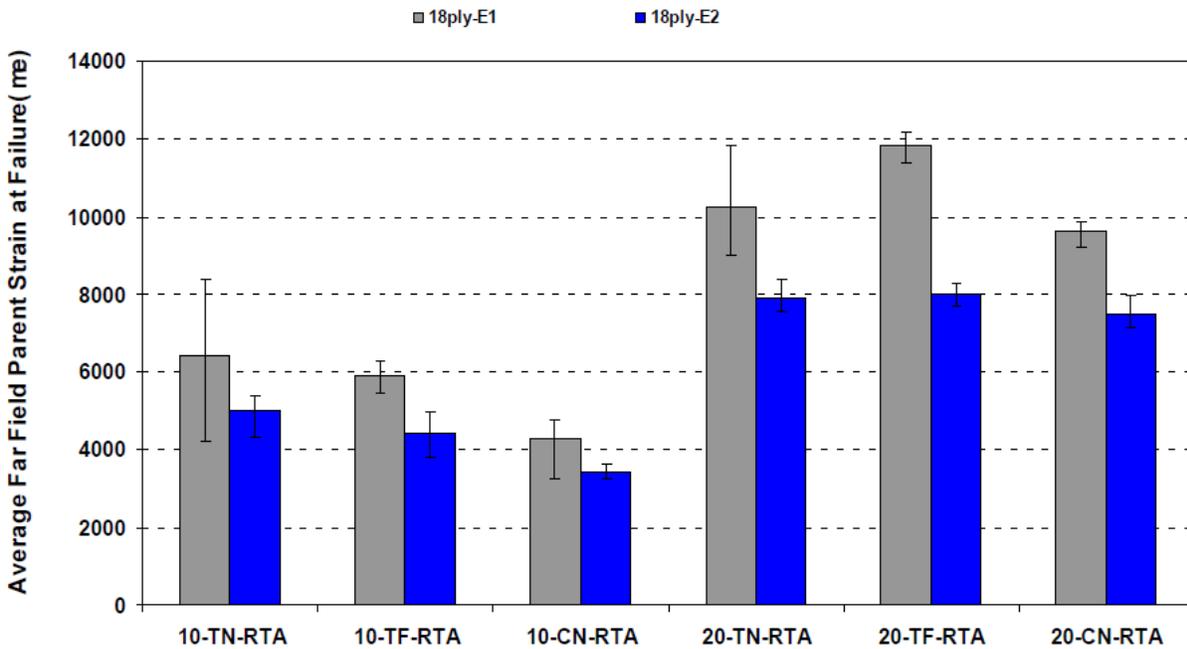
**Figure 60. Far field parent strain at failure of 18-ply laminate scarf repair configurations**

Figure 60 shows the far field parent ultimate strains obtained for all 18-ply static samples tested at room temperature. The 18-ply-E1-10 configurations yielded average ultimate parent far field strains of 6415 $\mu\epsilon$ , 5915 $\mu\epsilon$ , and 4278 $\mu\epsilon$  for the TN, TF, and CN specimens, respectively. Similarly, the 18-ply-E2-10 configurations yielded average ultimate parent far field strains of 4994 $\mu\epsilon$ , 4405 $\mu\epsilon$ , and 3445 $\mu\epsilon$  for the TN, TF, and CN specimens, respectively. The 18-ply-E1-20 configurations yielded average ultimate parent far field strains of 10253 $\mu\epsilon$ , 11824 $\mu\epsilon$ , and 9606 $\mu\epsilon$  for the TN, TF, and CN specimens, respectively. Similarly, the 18-ply-E2-20 configurations yielded average ultimate parent far field strains of 7884 $\mu\epsilon$ , 7979 $\mu\epsilon$ , and 7501 $\mu\epsilon$  for the TN, TF, and CN specimens, respectively. The larger repairs (1:20) had a higher strain to failure than the smaller repairs (1:10), and the softer substrate (E1) yielded higher strains to failure than the stiffer substrate (E2).

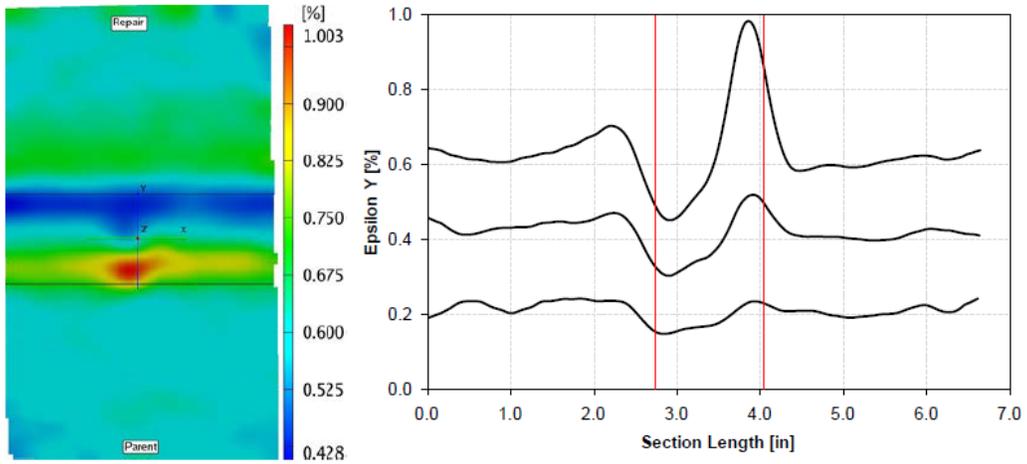
Figure 61. Y-strain distribution for 18-ply-E1-10-TN-RTA-02 scarf repair specimen

Figures 61–66 show representative y-strain maps and corresponding longitudinal y-strain section plots lengthwise through the center of specimens impacted at the TN, TF, and CN, respectively. The impact site created a stress riser at the damage location, which appears to be the locus of failure initiation, as shown in the figures.

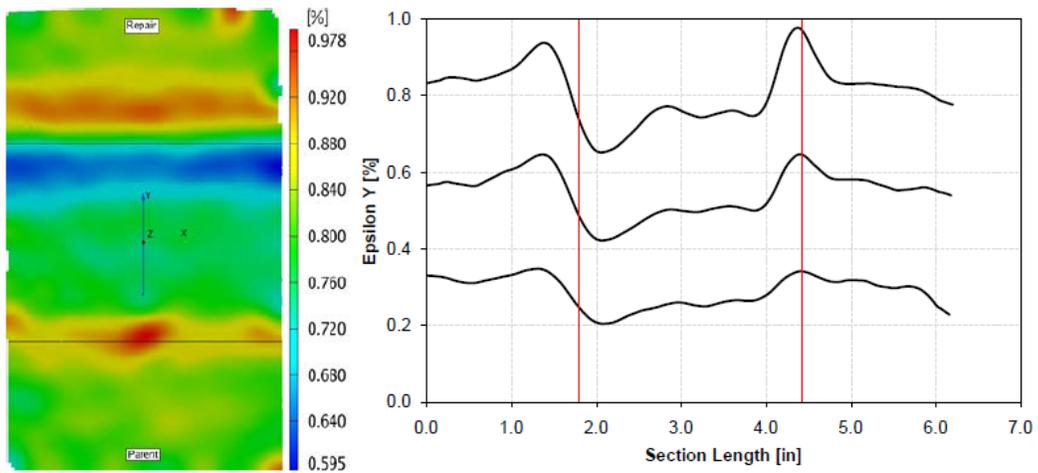
Figure 62. Y-strain distribution for 18-ply-E2-20-TN-RTA-03 scarf repair specimen

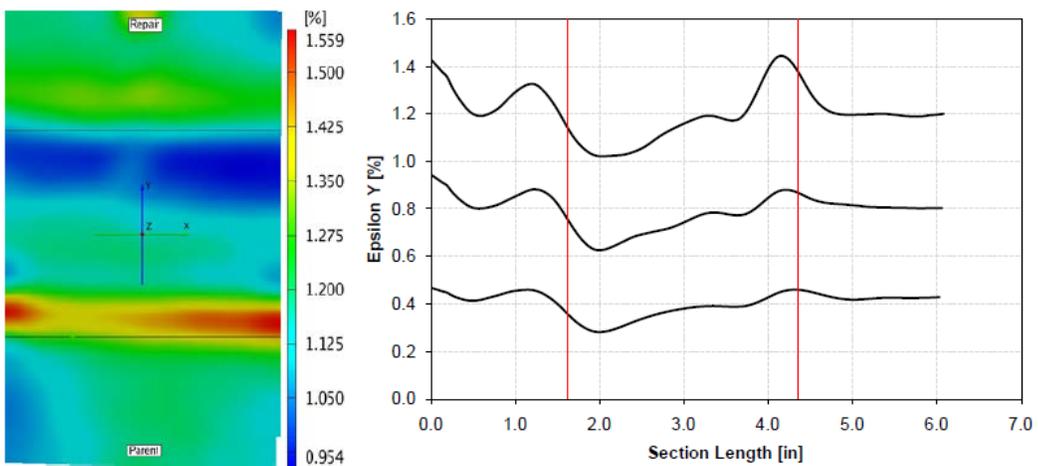
Figure 63. Y-strain distribution for 18-ply-E1-20-TF-RTA-03 scarf repair specimen

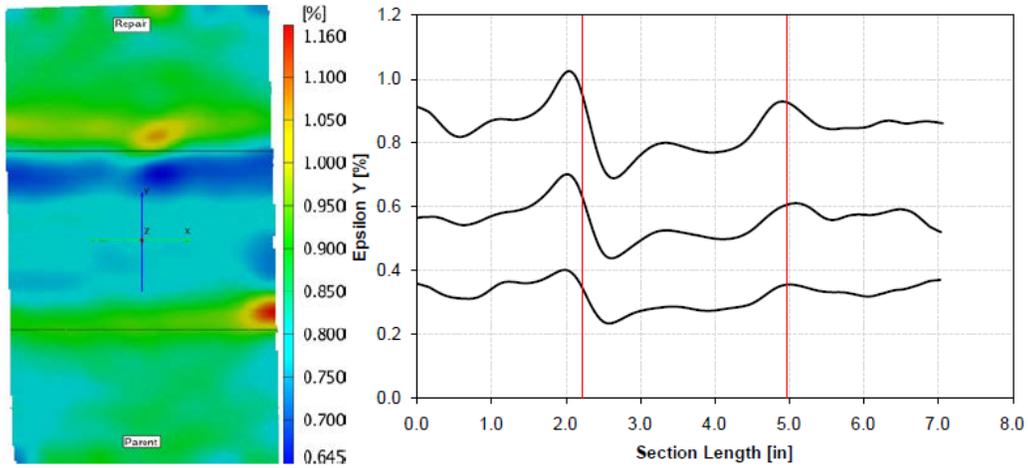
**Figure 64. Y-strain distribution for 18-ply-E2-20-TF-RTA-02 scarf repair specimen**

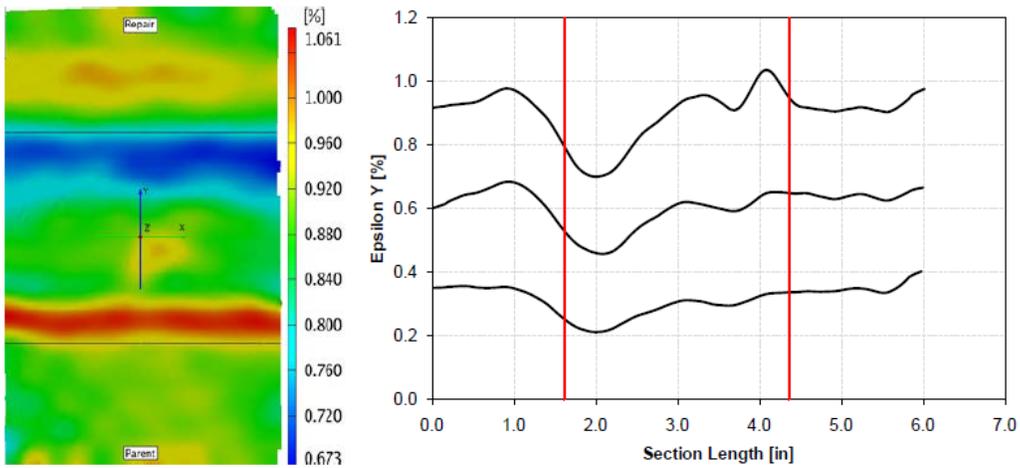
**Figure 65. Y-strain distribution for 18-ply-E1-20-CN-RTA-02 scarf repair specimen**

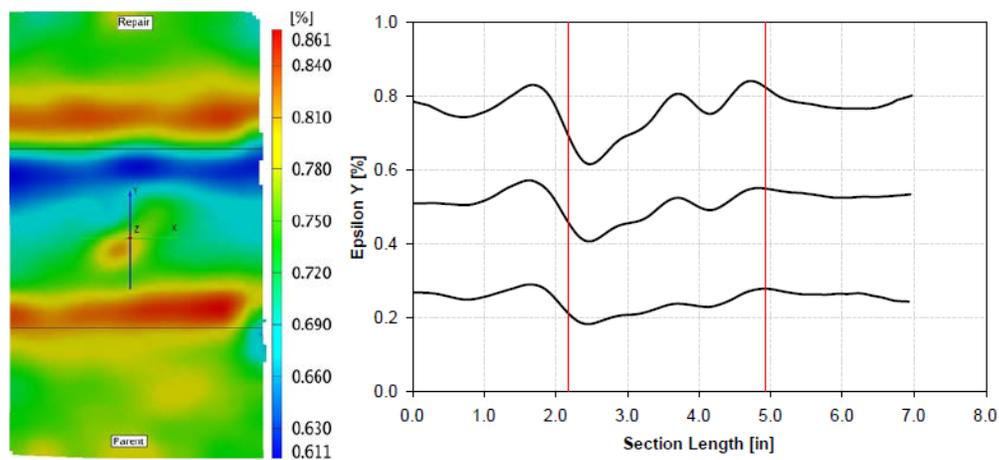
**Figure 66. Y-strain distribution for 18-ply-E2-20-CN-RTA-03 scarf repair specimen**

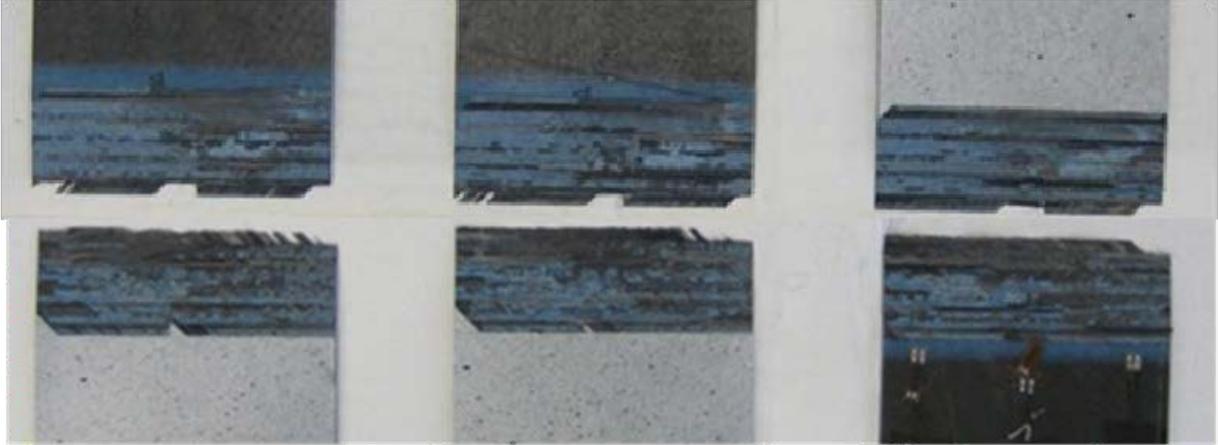
**Figure 67. Failure modes: 18-ply-E1-10-CN-RTA-XX**

Failure modes were very consistent for all specimens tested at room temperature and all specimens failed in the scarf joint. The dominant failure mode was a cohesive failure of the adhesive mainly in the 45 and 0 plies and a 90 ply peel/tension failure as shown in figures 67–72. For the specimens impacted at the CN, damage/disbond in the bondline was observed after failure.

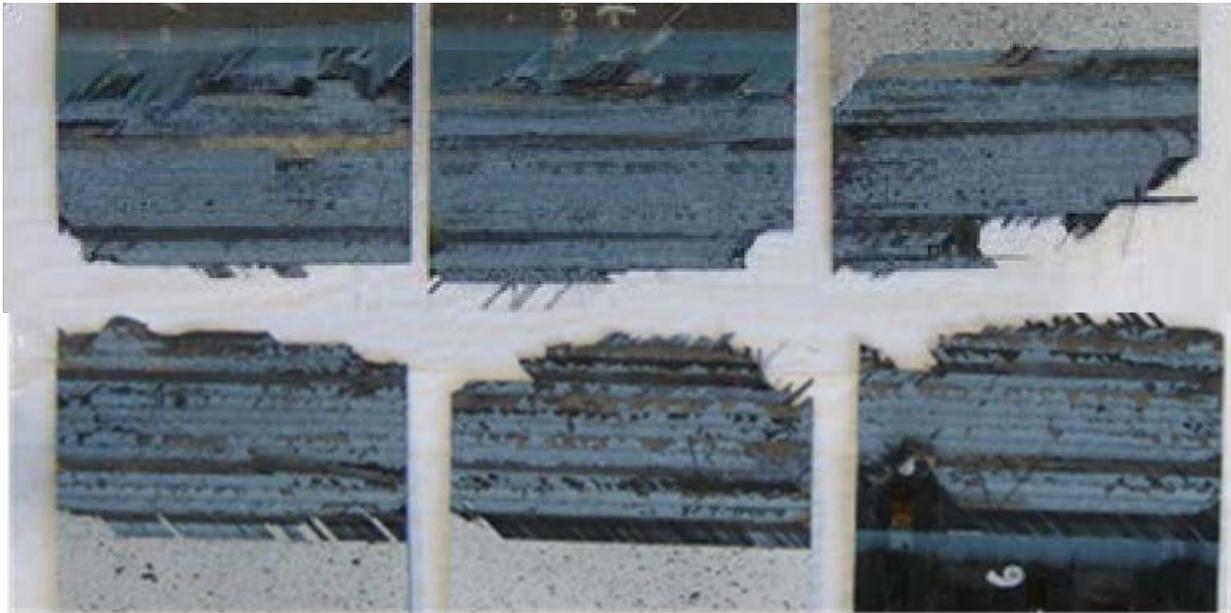
**Figure 68. Failure modes: 18-ply-E1-20-TF-RTA-XX**

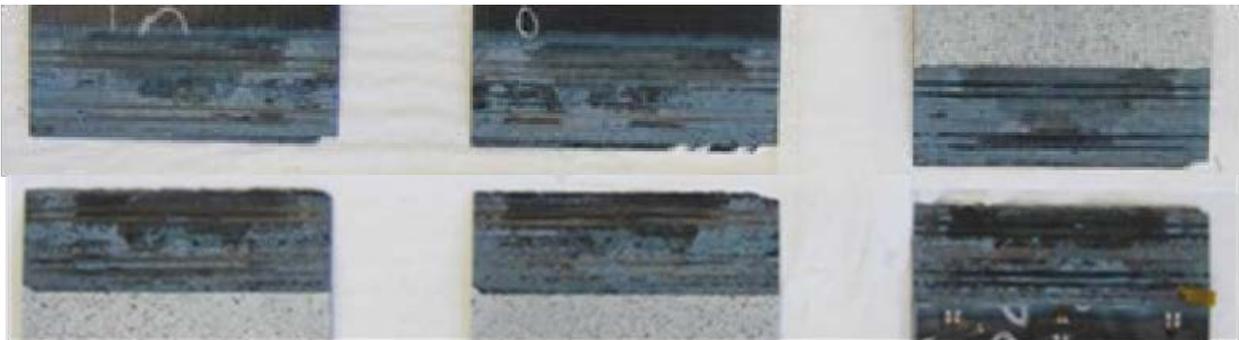
**Figure 69. Failure modes: 18-ply-E2-10-CN-RTA-XX**

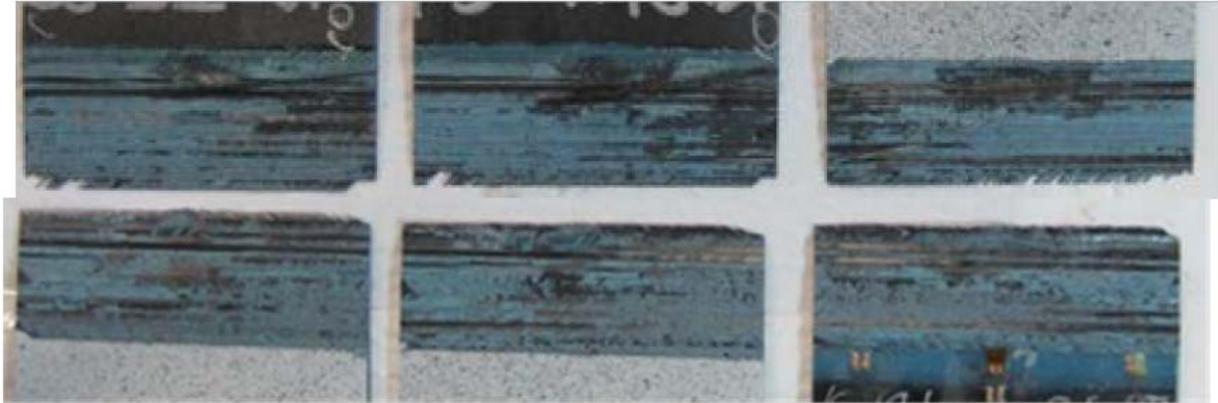
**Figure 70. Failure modes: 18-ply-E2-10-TF-RTA-XX**

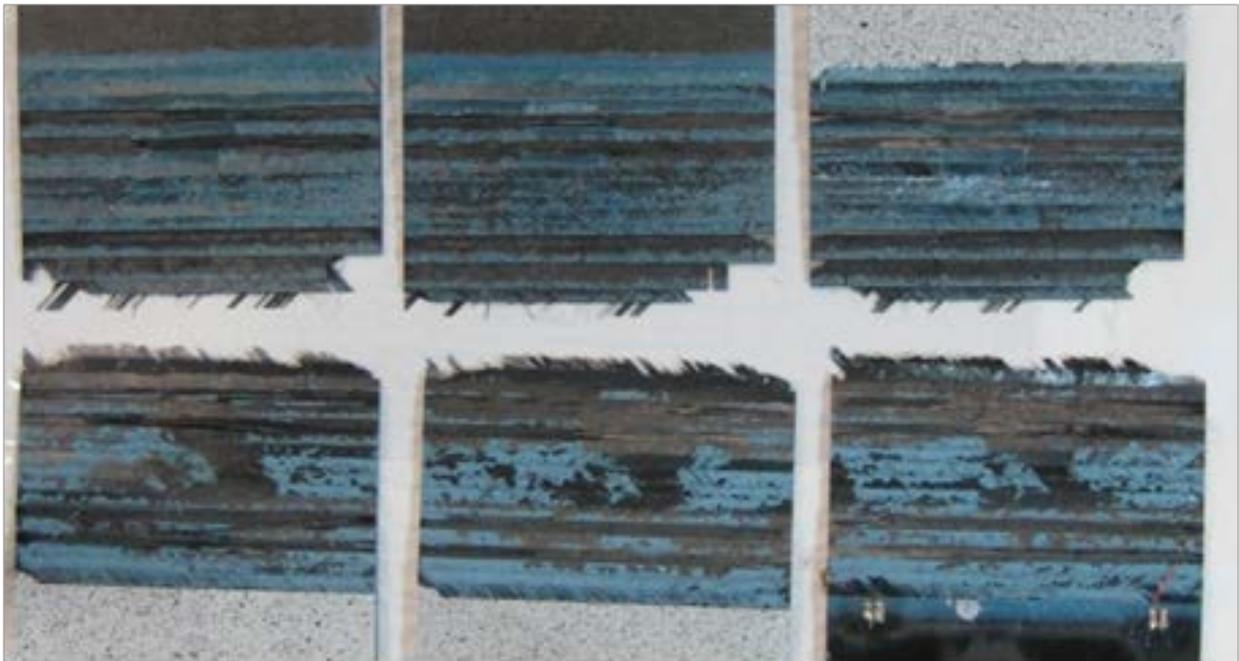
**Figure 71. Failure modes: 18-ply-E2-20-CN-RTA-XX**

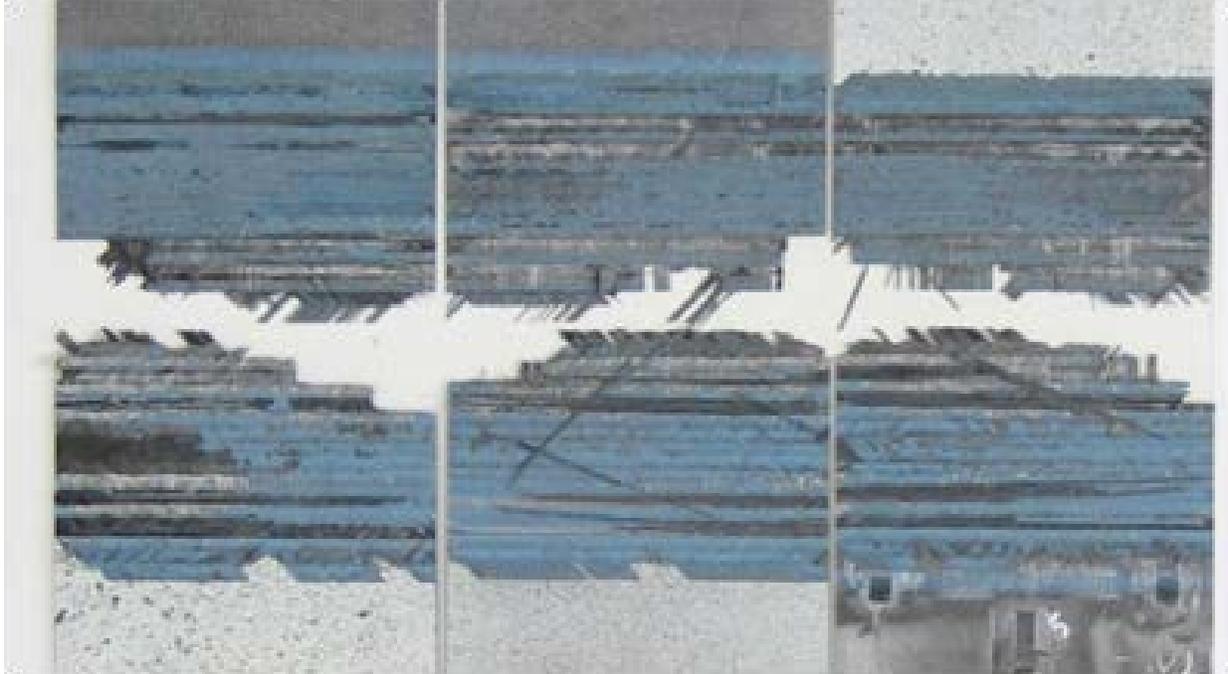
**Figure 72. Failure modes: 18-ply-E2-20-TN-RTA-XX**

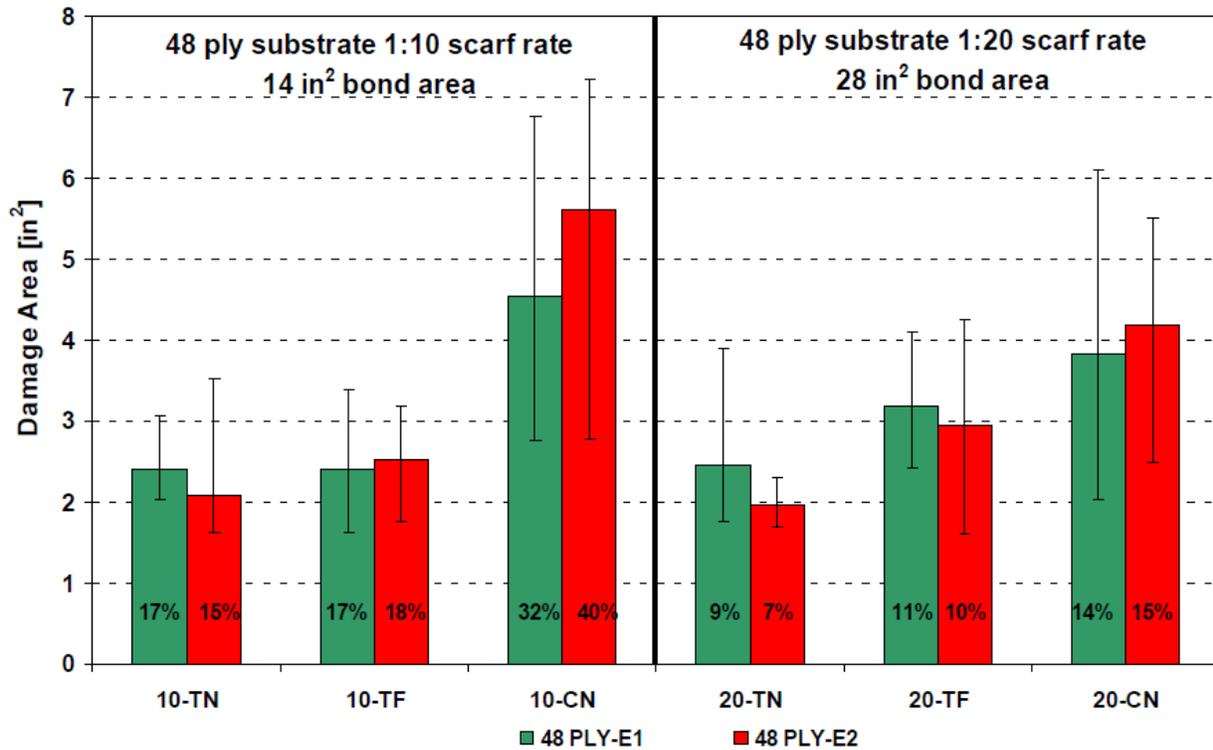
Figure 73 shows C-Scan planar damage areas for all 48-ply scarf repairs after impact. Figures 74–85 are representative C-Scan images obtained for all specimens subsequently tested at room temperature. As shown in figure 73, for both substrate moduli considered and regardless of scarf ratio, the TN impacts yielded the smallest damage areas followed by the TF impacts and the CN impacts. The same energy level inflicted at different sites in the repair yielded different damage sizes, with the impacts inflicted at the CN being the most severe. A close examination of the C-scans shows a large scatter in the damage areas obtained for identical samples impacted with the same energy level.

Comparing average damage areas, the TN and TF impacts yielded comparable damage areas for both 1:10 to 1:20 scarf ratios. The TN impact yielded 17% and 15% bond damaged area for the 48-ply-E1-10-TN and 48-ply-E2-10-TN specimens, respectively, and 9% and 7% damaged bond area for the 48-ply-E1-20-TN and 48-ply-E2-20-TN, respectively. The TF impact yielded 17% and 18% damage at the scarf overlap area for the 48-ply-E1-10-TF and 48-ply-E2-10-TF specimens, respectively, and 11% and 10% damage at the scarf overlap area for the 48-ply-E1-20-TF and 48-ply-E2-20-TF, respectively. The CN impact yielded 32% and 40% damage at the scarf overlap area for the 48-ply-E1-10-CN and 48-ply-E2-10-CN specimens, respectively, and 14% and 15% damage at the scarf overlap area for the 48-ply-E1-20-CN and 48-ply-E2-20-CN, respectively.

Figure 73. Impact data summary for all 48-ply scarf repair specimens

The ultimate loads of the damaged scarf repairs were compared to those of pristine, undamaged repairs. The failure load values shown in figure 88 correlated very well with the C-Scan data summarized in figure 73; the specimens with the largest damage yielded the lowest residual strength. The 48-ply-TN specimens produced the highest residual strength regardless of scarf/repair size (smallest damage area), followed by the TF specimens, with the CN specimens yielding the lowest strengths (largest damage area). The magnitude of the strength degradation observed for the 1:10 scarf repairs was more severe than that observed for the 1:20 scarf repair samples. For the same impact energy level inflicted on the 1:10 and 1:20 scarf repairs, the percentage of residual structurally sound bonded area around the damage was higher for the larger scarf repairs (1:20).

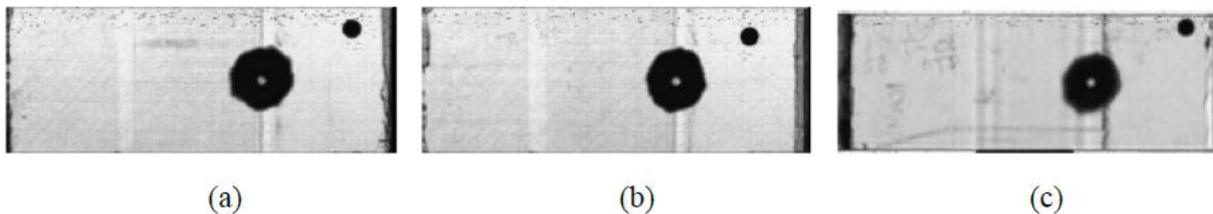
Figure 74. C-scans of 48-E1-10-TN-RTA-(1, 2, 3) of damage area and depth, respectively:  
 (a) 2.1368 in<sup>2</sup>, 0.009 in; (b) 2.054 in<sup>2</sup>, 0.0095 in; (c) 2.22 in<sup>2</sup>, 0.0095 in

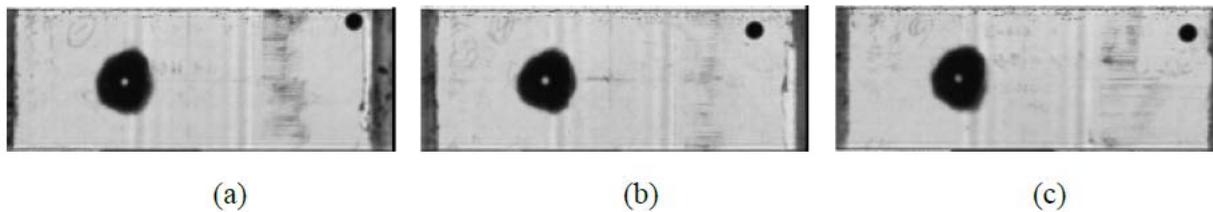
Figure 75. C-scans of 48-E1-10-TF-RTA-(1, 2, 3) of damage area and depth, respectively:  
 (a) 2.152 in<sup>2</sup>, 0.011 in; (b) 2.1564 in<sup>2</sup>, 0.0115 in; (c) 2.0228 in<sup>2</sup>, 0.0105 in

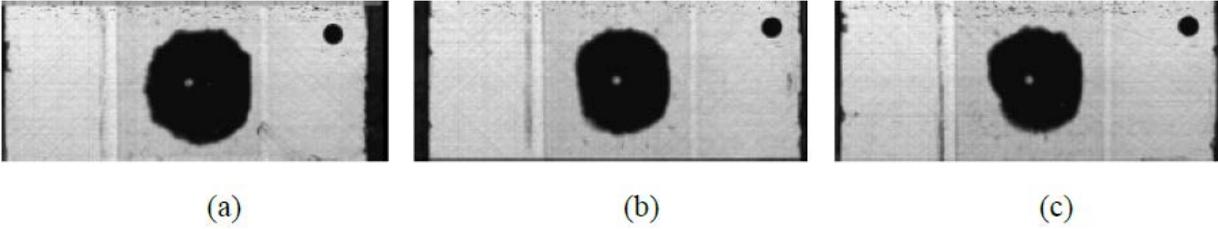
**Figure 76. C-scans of 48-E1-10-CN-RTA-(1, 2, 3) of damage area and depth, respectively: (a) 6.2796 in<sup>2</sup>, 0.0095 in; (b) 5.0008 in<sup>2</sup>, 0.008 in; (c) 4.808 in<sup>2</sup>, 0.012 in**
